NASA TN D-7951

**APOLLO EXPERIENCE REPORT -
COMMAND AND SERVICE MODULE
SEQUENTIAL EVENTS CONTROL SUBSYSTEM**

Gary W. Johnson

*Lyndon B. Johnson Space Center
Houston, Texas 77058*

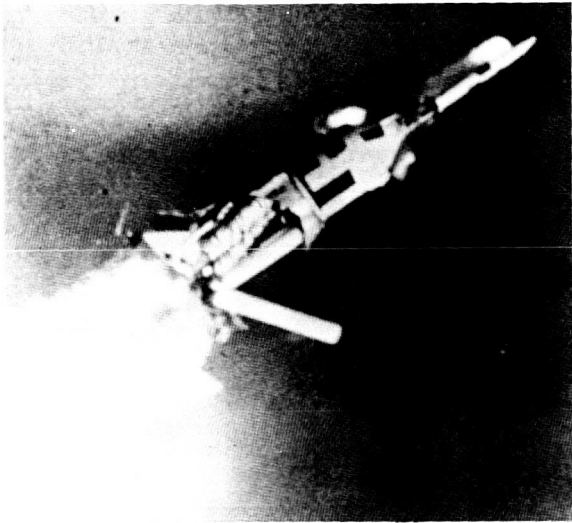
Figure 7. - Launch vehicle breakup initiates abort.

On May 19, 1965, the need for an automatic abort system was demonstrated dramatically during the BP-22 flight at the White Sands Missile Range. The launch vehicle disintegrated because of excessive roll when a control surface failed hard-over during launch (figs. 7 and 8). When the abort-initiate wires broke in the launch vehicle and deenergized the CM abort relays, the abort was initiated automatically. This problem highlighted the usefulness of a hot-wire abort system (an opening in wires powered from the spacecraft initiates the abort) to detect launch vehicle structural failure and safely abort the flight and recover the spacecraft.

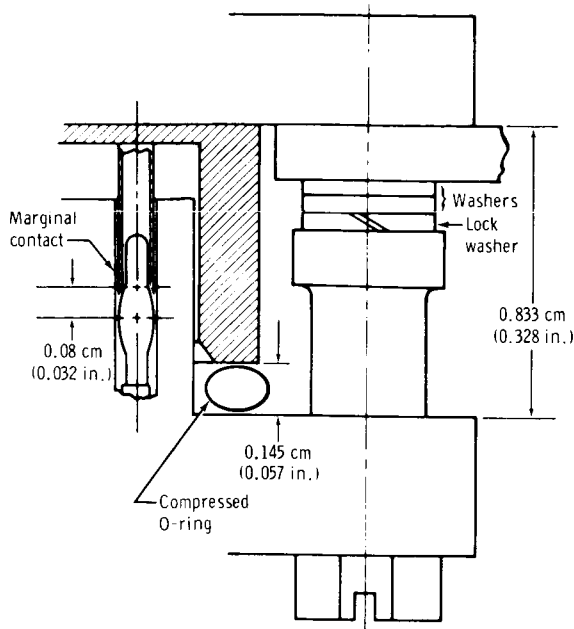
Figure 9.- Master event sequence controller fuse module, original design.

In July 1969, during acceptance testing of an MESC, the apex-cover-jettison function failed to occur. Investigations revealed that one pin of a fuse-module connector was not seated properly. Analysis of the fuse-module connector-assembly tolerances indicated that a marginal pin/socket engagement condition could exist (fig. 9). Corrective action was taken to remove two flat washers and to insert a thinner O-ring (0.124-centimeter (0.049 inch) compared with 0.178-centimeter (0.070 inch) or 0.157-centimeter (0.062 inch) thick (fig. 10)) to provide additional engagement distance. This change was effective on CSM-108 and subsequent vehicles.

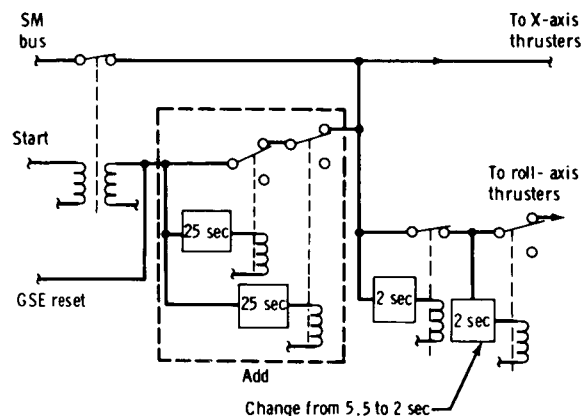
Figure 11.- Service module jettison controller changes.

At that time (August 1969), a post-flight SM trajectory analysis revealed that the SM maneuvers after CM-SM separation were not satisfactory for preventing possible CM-SM recontact during entry. In November 1969, a directive was issued to modify the SMJC (fig. 11). This modification consisted of replacing the 5.5-second plus-roll engine time delays with 2.0-second time delays and adding 25-second time delays to turn off the minus-X RCS engines.

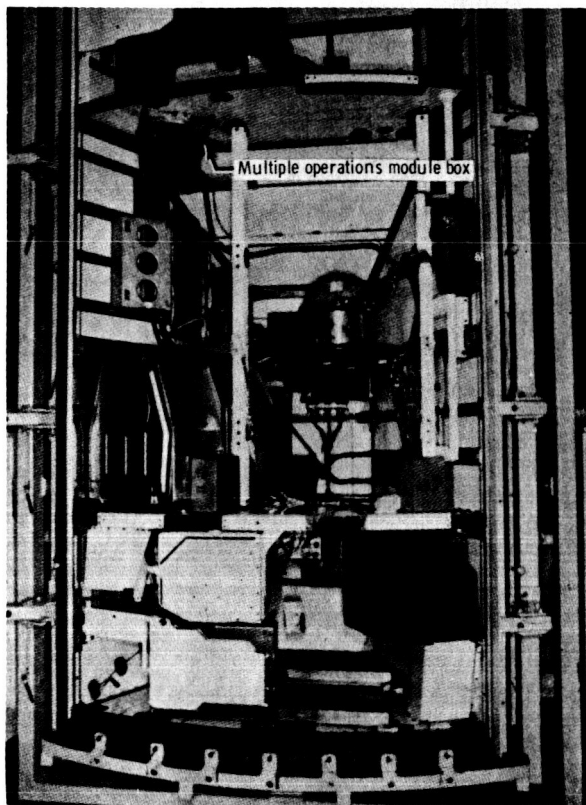
Figure 12.- Multiple-operations module box location.

During vibration testing, one of the redundant relays that switches alternating-current power to the experiments failed to operate. Investigations revealed that the armature-return spring had broken. Microscopic inspection revealed the break to be adjacent to a tool mark. The break pattern indicated that the fracture resulted from

material fatigue. A design-evaluation vibration test was conducted on the relays to determine if the failure was caused by extended vibration exposure or by high levels of vibration (or both). Based on this testing, it was concluded that the failure was caused by an isolated quality defect (the tool mark); however, to ensure that marginal relays were not installed in the MOM box, a relay-component vibration-screening test before installation was implemented.

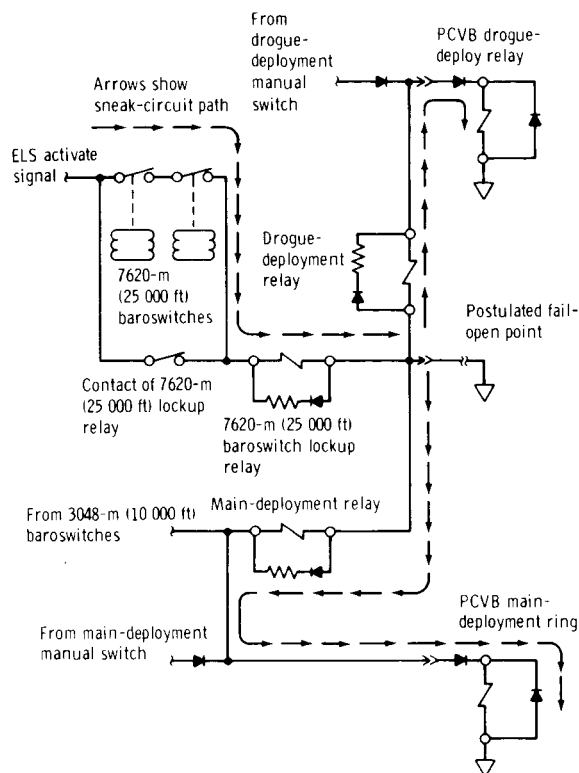
Figure 13.- Earth-landing system sequence controller sneak circuit.

In December 1971, an Apollo sneak-circuit bulletin for CSM-113 identified a sneak circuit in the ELSC and PCVB that could possibly result in premature deployment of the parachutes. If the single ground connection to the ELSC should fail open, then a sneak circuit would exist (fig. 13) that could result in deploying the drogue and pilot parachutes under the apex cover and cause loss of the crew. The corrective action taken was to add a redundant ground wire to the ELSC on CSM-113 and subsequent vehicles.

This crew-safety hazard, which was discovered by the sneak-circuit group, underscores the need for sneak-circuit analyses to be run on all critical spacecraft circuitry. Also pointed out is the unseen hazard that can exist when wiring modifications are made external to an electrical box to add additional components. This addition nullifies the original design of the box and allows circuit paths to exist that the original designer had never planned. In this case, relays were added to the PCVB. Rather than redesign the ELSC with the added relays incorporated (which would have been more desirable), it was decided to tie the wiring into the ELSC external to the controller.
